# PRODUCT FAULT INFORMATION

19.August 2019

We have discovered incorrect information in technical documentation for Asymmetrical Horn antennas: **HG3-TP-A20-30, HG3-TP-A60, and HG3-TP-A90**

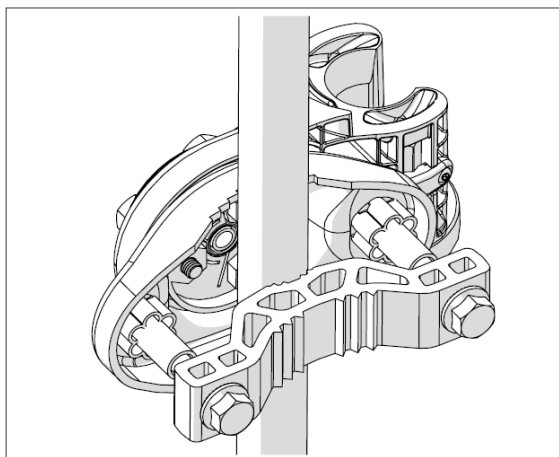
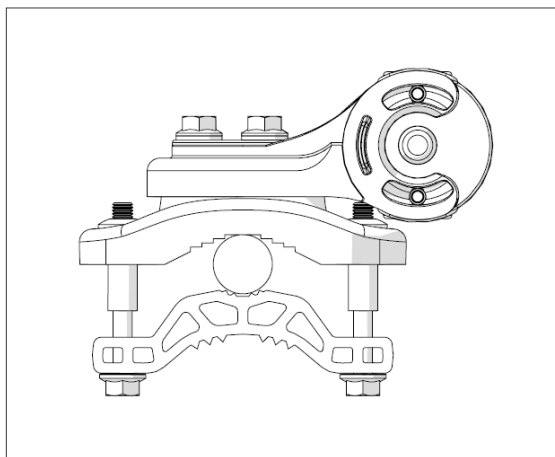
Step 4

**WRONG**

Place the AH-TP Bracket like this for pole diameter of **22** - 49mm

**The correct span of diameters is 36 - 49 mm.** Similar mistake has been identified and corrected in Product datasheets.

We advise you not using a pole with diameter smaller than 36 mm because of a risk of potential galling of the bolts which damages the bracket beyond repair. Our general recommendation is using the largest possible pole diameter within above mentioned correct span of diameters.
