Effective Date: 01.01.2020  
Expiry Date: 31.12.2020  
Type: Warranty Service Document  
ID: FSA-01-2020  
Affected part numbers: HG3-xx-xxx

## PRODUCT FAULT INFORMATION

We have noticed a possible problem with cracking radomes. The problem occurs with radomes on HG3 product series, which are made of HDPE material. The cracks randomly appear on the edge of the radome. The cracks have no influence on the RF functionality of the antennas.

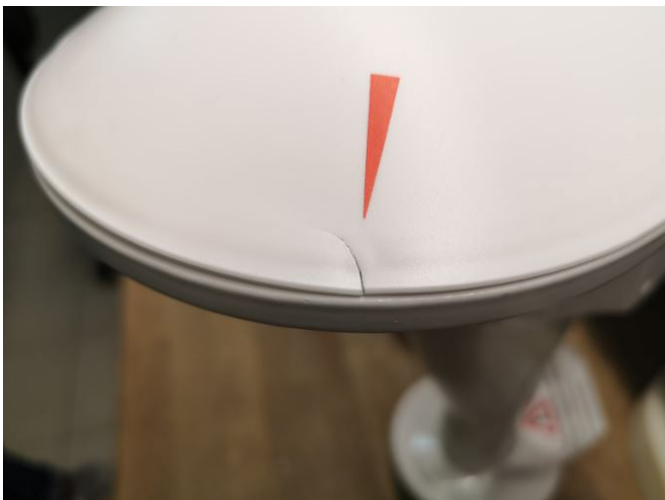
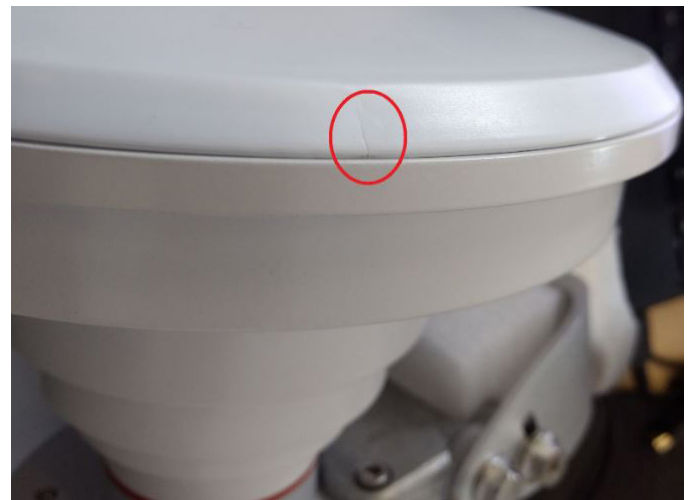
Examples of the cracks:

The issue is caused by component supplier. We currently take precautions to remove the problem so that it does not occur in the future again. We are sorry for any inconvenience.

In case you have discovered this fault with the antennas you purchased, please note that we accept this fault and will authorize RMA. For placing an RMA, please contact your Distributor.
