Date: 10.11.2015  
Type: RF Alert  
Document ID: CDI-01-2015

# CORRECT DEVICE INSTALLATION

Product: **TwistPort™ Adaptor for ePMP™**

Device: **ePMP™ 1000 5GHz Connectorized Radio with Sync**

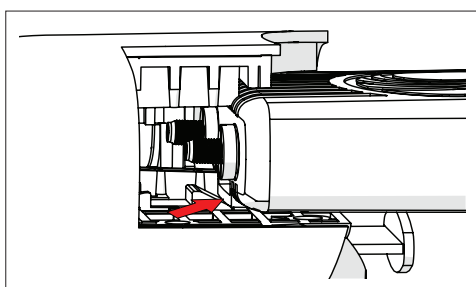
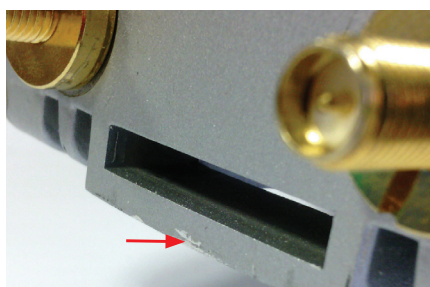
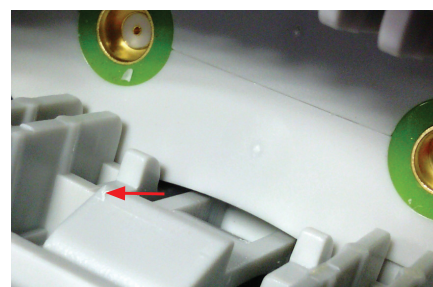
When locking the ePMP™ 1000 5GHz Connectorized Radio with Sync device in the TwistPort Adaptor for ePMP, the ePMP Sync device can get stuck.

The problem can occur because of a sharpe edge on the front metal part of ePMP Sync device as shown on the pictures below.

To avoid the sharp edge of the ePMP Sync device to come in contact with the slant plastic area follow these steps:
