Effective Date: 29.10.2014
Expiry Date: 31.12.2014
Type: Warranty Service
Document ID: FSA-01-2014

FIELD SERVICE ALERT

StationBox® ALU

StationBox® ALU CARRIER CLASS

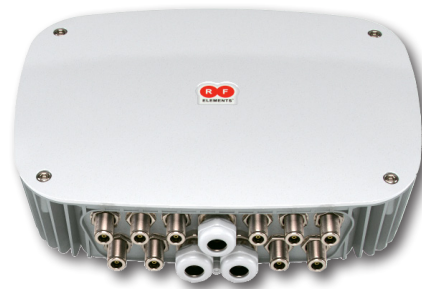
The fault part of the product is enclosure cover. We are suspicious that due to this fault, some of the products may not be able to seal correctly to be waterproof.

If you purchased product that shows incorrect top cover position, please contact your reseller or distributor with RMA requirement. We will replace the top cover as warranty fault.

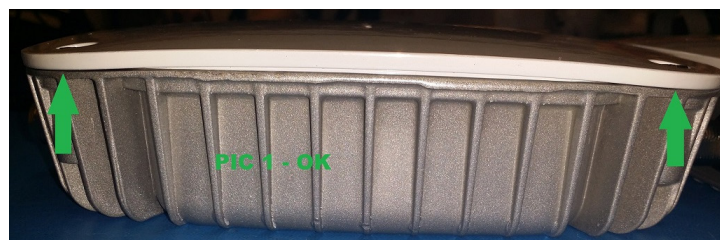
To identify faulty product, please check following pictures: Picture 1 shows OK product with top cover in correct position. Picture 2 shows faulty product - top cover is in incorrect position due to residual material that blocks the cover from closing the StationBox tight.
